**CHESSMAN DAM REHABILITATION INVESTIGATION**

**PART I**

**GEOTECHNICAL AND PRELIMINARY  
ENGINEERING**

**PROJECT 500-107-01-(33)**

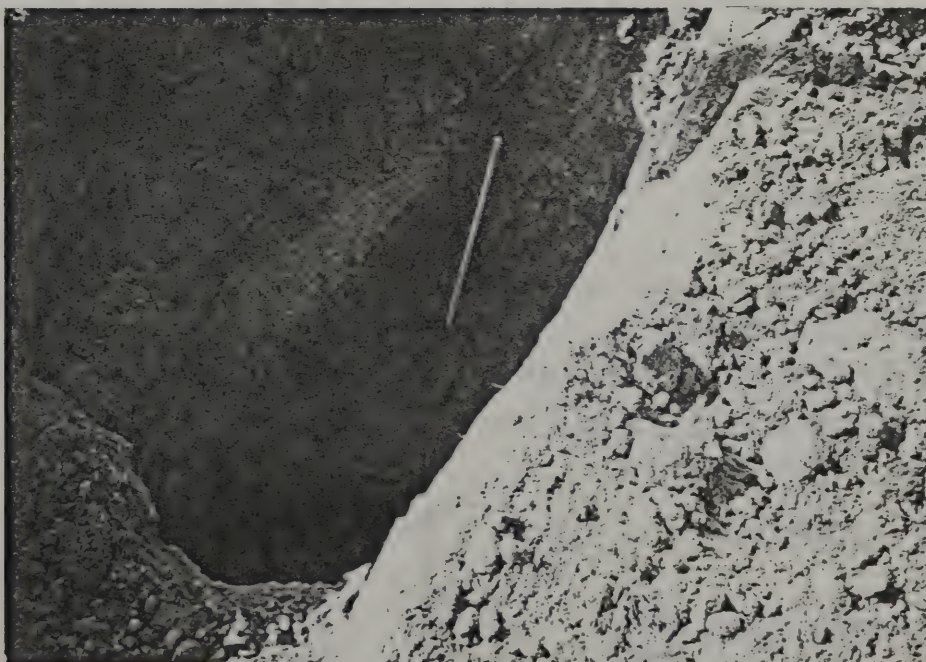
The concrete cutoff wall was closely inspected in Test Pits 1 through 3. It was encountered at about elevation 101 and is approximately 1 foot wide at the top. The condition of the cutoff appeared to be good. Cracking was not evident and no reinforcing bars were detected or observed in the wall. Since borings made immediately adjacent to the cutoff revealed in-place sand, clay and gravel between the embankment fill and the quartz monzonite bedrock, it can be concluded that the cutoff does not extend to bedrock. The exposed cutoff, as well as concrete cores obtained from the wall, are shown below. Further information on the concrete cores is summarized in Northern Engineering and Testing's December 1, 1983 report.

Photograph 1 - Concrete cutoff wall exposed in Test Pit 3.

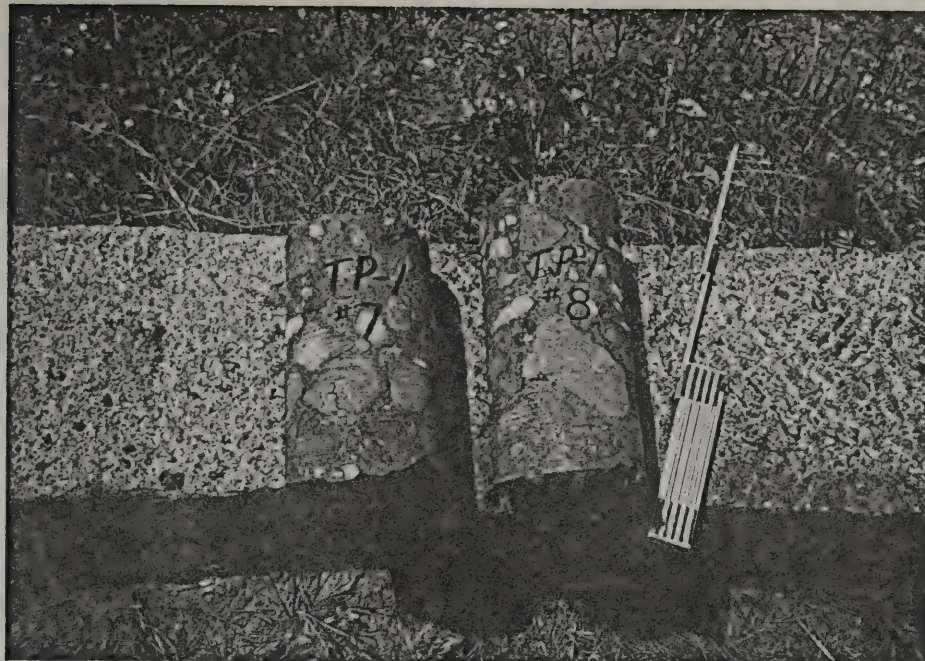
Photograph 2 - Concrete cores obtained from cutoff at Test Pit 1.
